Manhole Inspection Summary

Manhole # S35MM1007MH

Insp Date: **3/12/07 4:00 PM**

Location Address: **4403 UNDERWOOD RD**

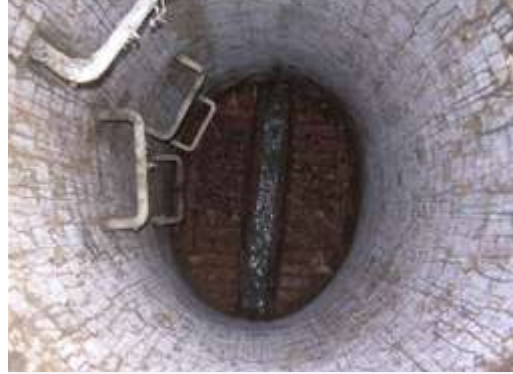
Top View

Evidence of surcharge - Bench debris.

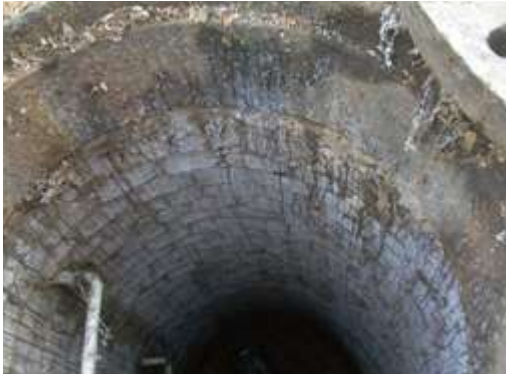
Defect

Frame leaks. Adjustment deterioration and infiltration. Corbel and Barrel infiltration.

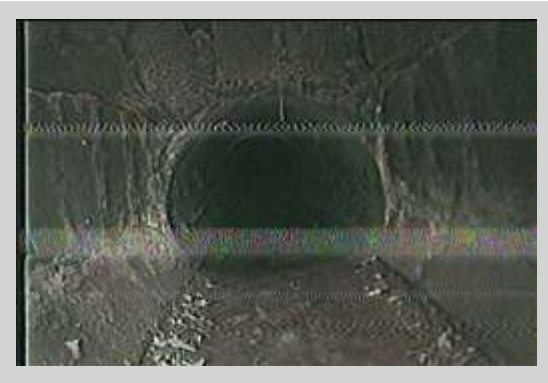
8 in. Circular Gravity Sewer Pipe Out @ 12 O'Clock

Channel deterioration.

Infiltration: **None** Pipe Seal Cond: **Cracked**

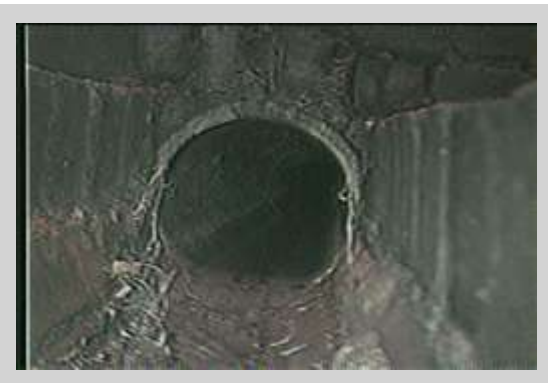
8 in. Circular Gravity Sewer Pipe In @ 6 O'Clock

Channel root intrusion.

Infiltration: **None** Pipe Seal Cond: **Cracked**
